FINAL REPORT OF SPECIFIC PURPOSE LIDAR SURVEY

LiDAR, Breaklines and Contours for Jefferson County, Florida

State of Florida
Division of Emergency Management
Contract 07-HS-34-14-00-22-469
Task Order 20070525-492718a
PDS Task Order B

October 30, 2009

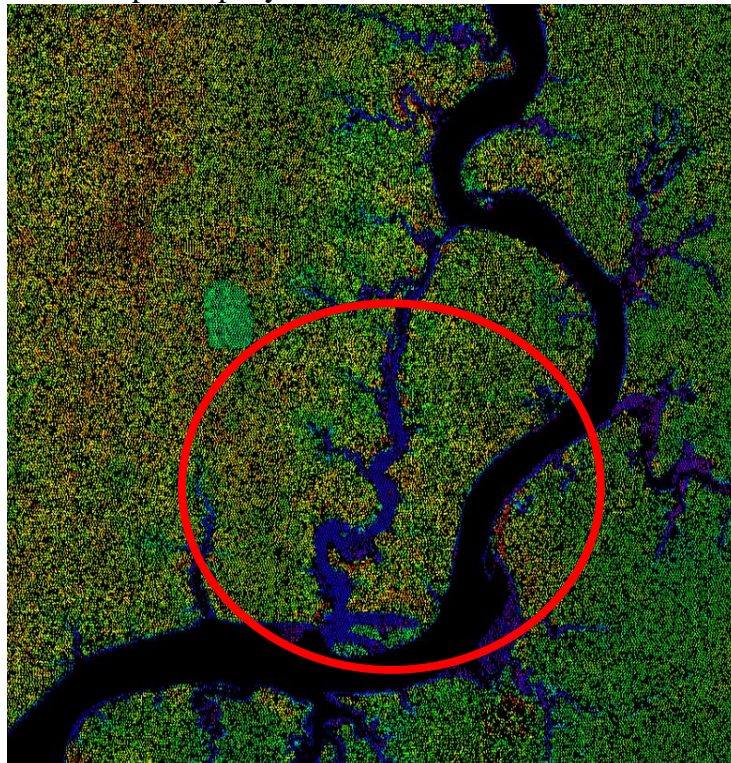
LID 010203 – in several areas ground points were found in the .LAS files that should have been classified as water (see Figures 7 & 8). This was likely due to an automated filter confusing the points with ground points, based on elevation. These tiles were rejected and subsequently corrected by The Sanborn Map Company.

Figure 13 Tile 010203 – example of points classified as Class 2- ground points in a water body.

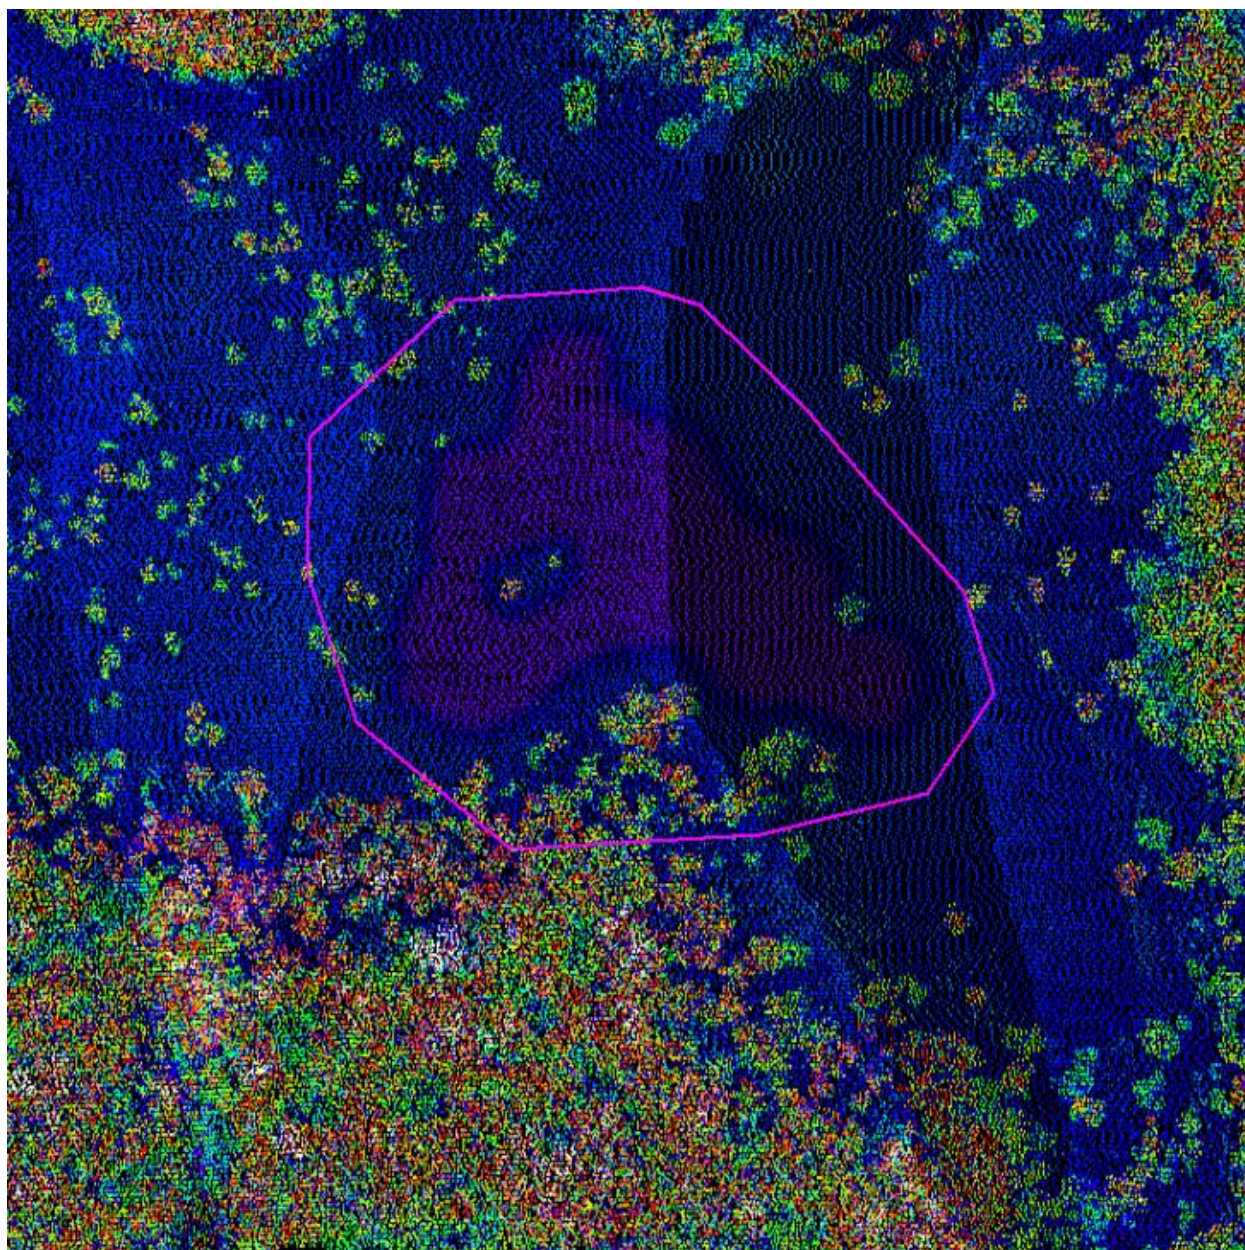
Figure 14 Tile 010083 – example of points classified as Class 2- ground points in a water body.

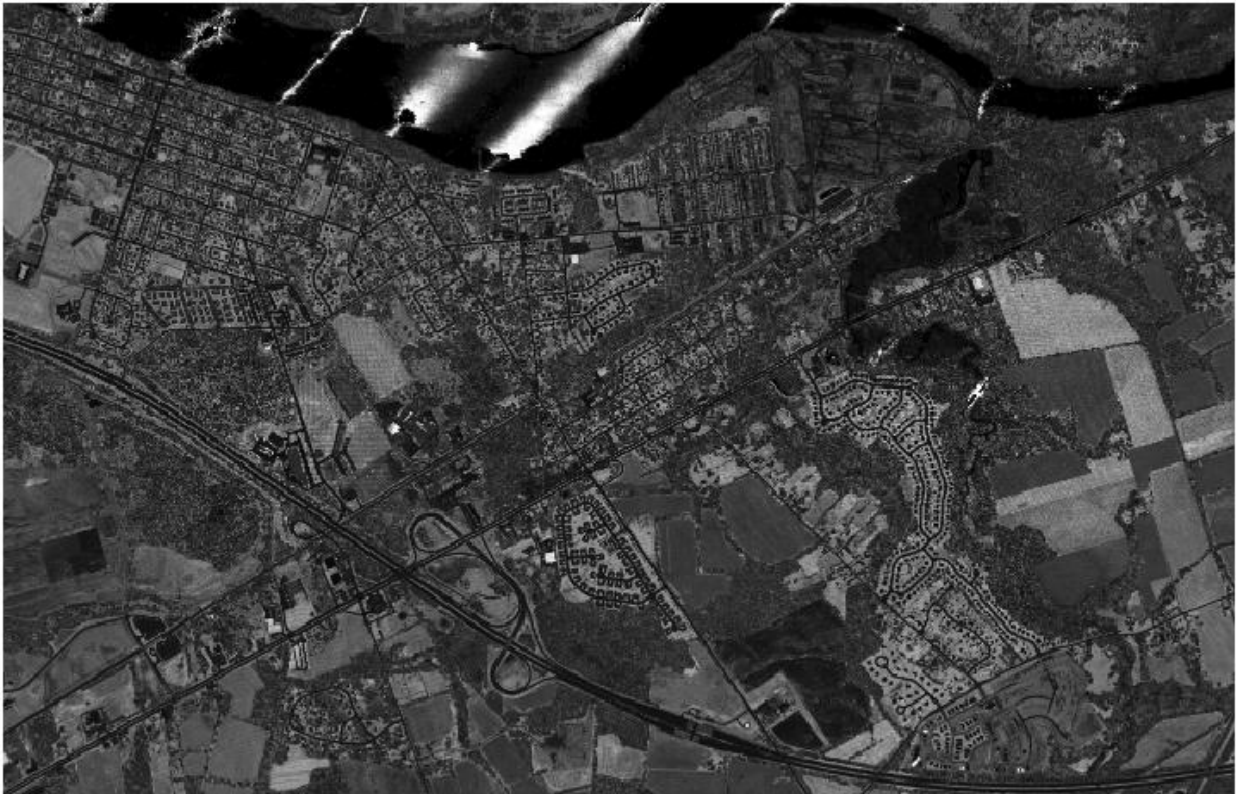
Figure 15 is an example of a LiDAR intensity image, showing streaks over rivers and areas of standing water; such intensity streaks exist in LiDAR datasets nationwide. QA reviews identified the presence of anomalous LiDAR intensity values within the coastal regions of Jefferson County. The PDS team has reviewed the issue and while it was determined that the anomalies do not cause any of the datasets to fall short of the specifications of the project nor do they affect the overall integrity of the data, these anomalies have been corrected in the LAS data. This report documents the root cause, the geographic extent of the anomalies for this county, the geographic extent of areas exceeding the vertical specification of the contract expressed as % of the total county area, and modifications performed on the dataset to correct these anomalies.

Figure 15. LiDAR intensity streaks over water and marshy areas

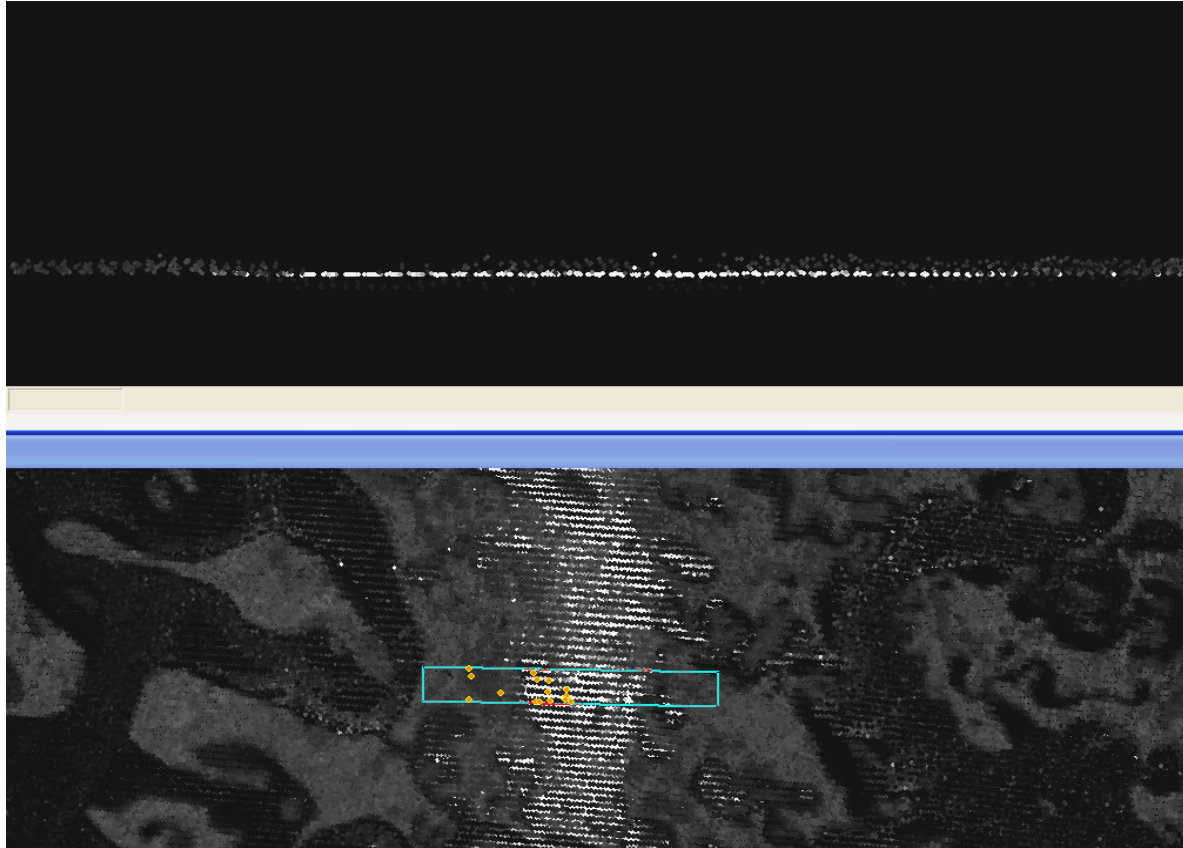
Streaks caused by anomalous readings are most visible in the intensity image view of the affected LiDAR data. Each streak is characterized by high values that far exceed the normal range of values found in the surrounding data. In Figure 16, this anomaly is evident in both the overhead view and the profile of the area.

Figure 16. Profile of anomaly

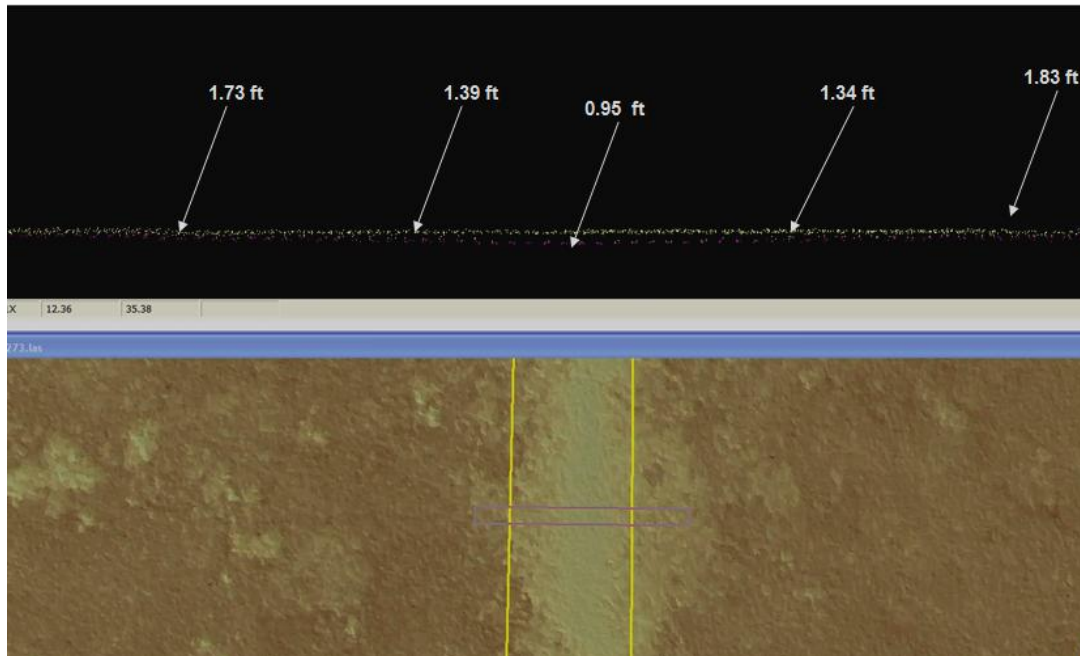
The anomalous intensity values cause the elevation readings of the LiDAR points to be falsely depressed. This effect can be seen when generating a TIN using the Class 2 points in the area. In Figure 17, the elevation measurements are displayed over a cross section of a representative anomaly. The greatest error in elevation is located at the center of the anomaly with the elevations gradually rising up at the edges to meet “true” ground elevation. This screenshot is representative of the errors found.

Figure 17. TIN and profile of anomaly

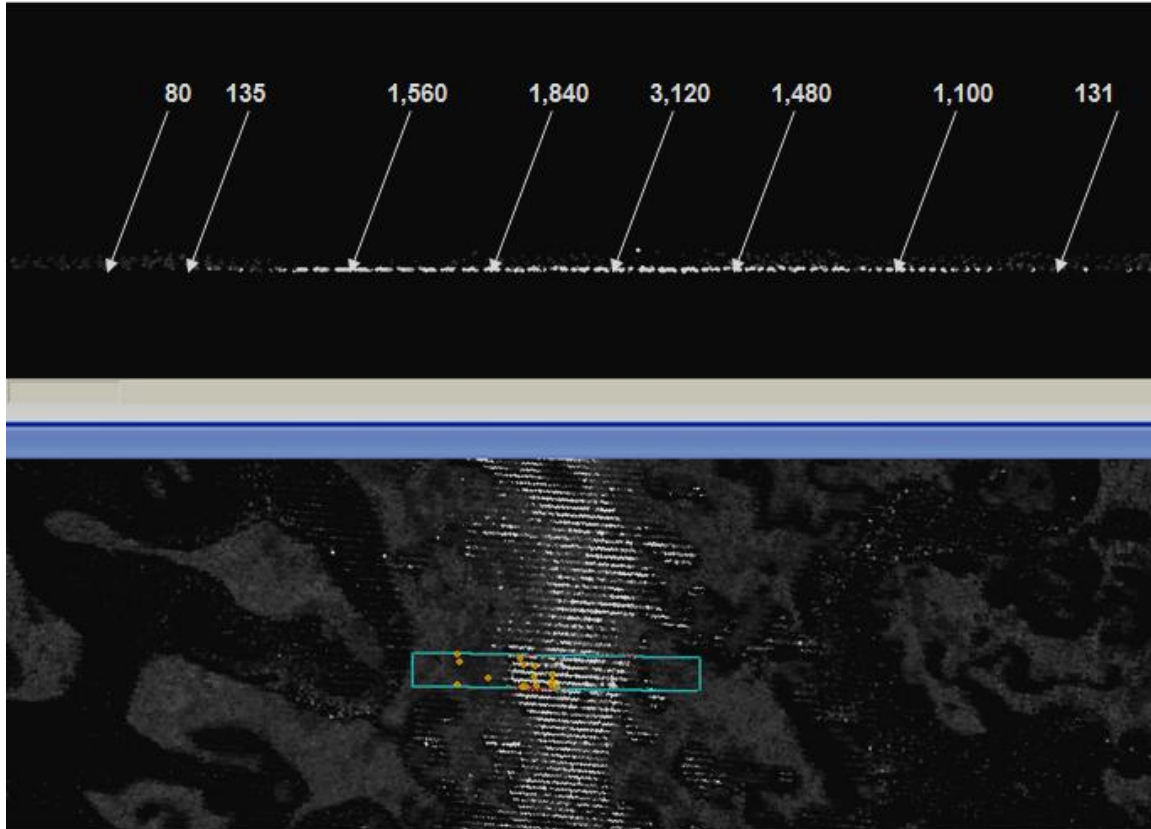
Figure 18 illustrates the connection between abnormally high intensity values and depressed elevation values within one of the anomalies. The highest intensity value is at the center of the anomaly with the values gradually decreasing until they are within a normal range at and beyond the edges of the anomaly.

Figure 18. Cross section of anomaly with intensity values mapped

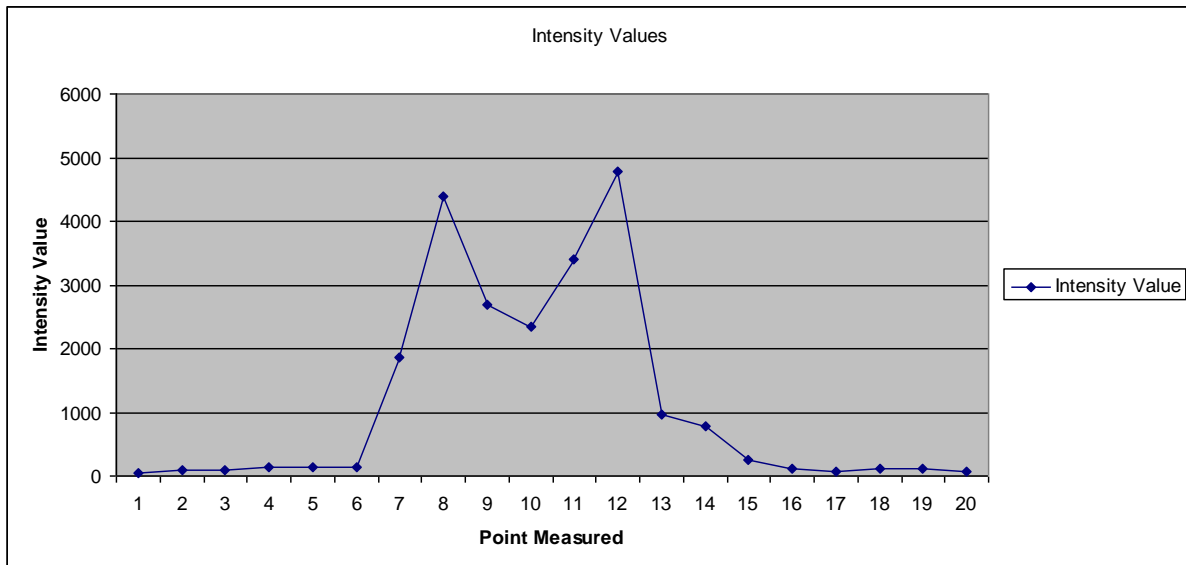
The following graphs (Figures 19-20) further demonstrate the correlation between the anomalous intensity values and falsely depressed elevations.

Figure 19 Graph of measured intensity values within profile of an anomaly

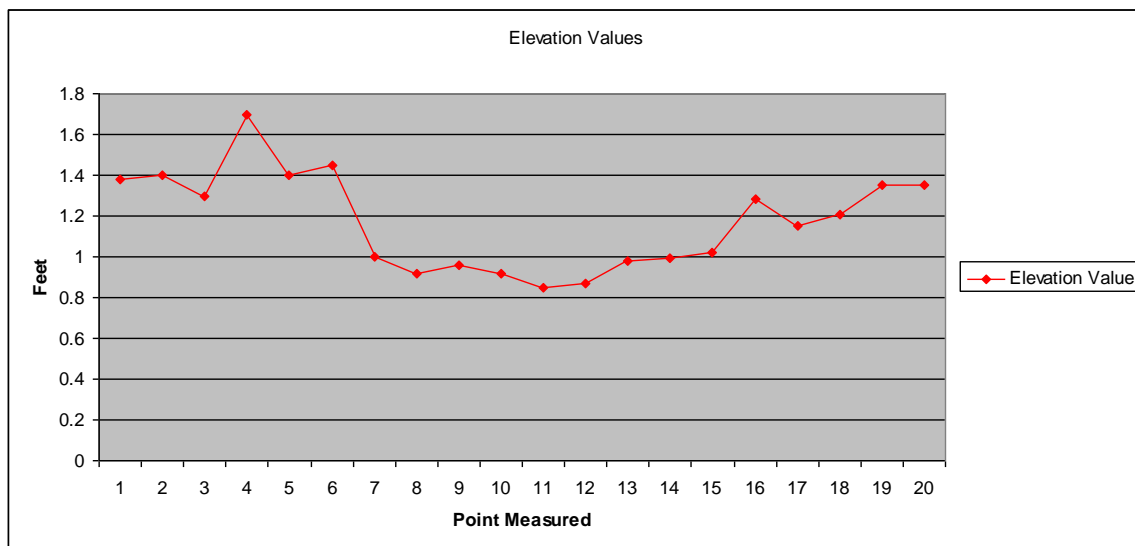
Figure 20. Graph of corresponding elevation values for points depicted in Figure 4

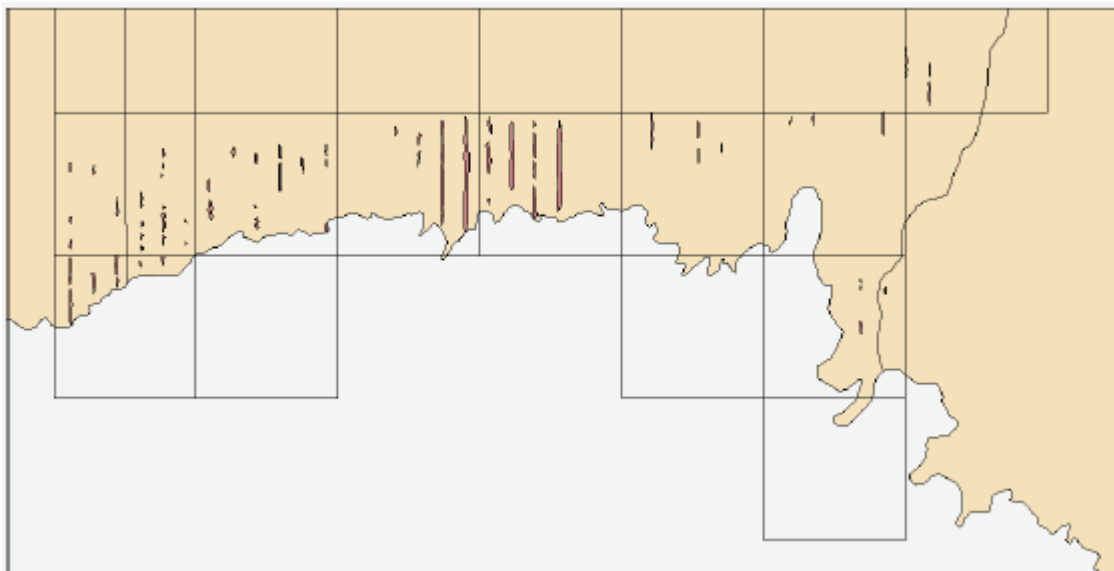
1. Total land area affected by intensity anomalies – 0.43 sq. mi.
2. Total land area of anomalies exceeding a 1 foot error – 0.11 sq. mi.
3. Percentage of project area in Jefferson County exceeding a 1 foot error due to intensity anomalies - ~0.018%
4. A location map is provided in Figure 21. Figure 22 is a zoom of the affected area.

Figure 22. Zoom of affected area

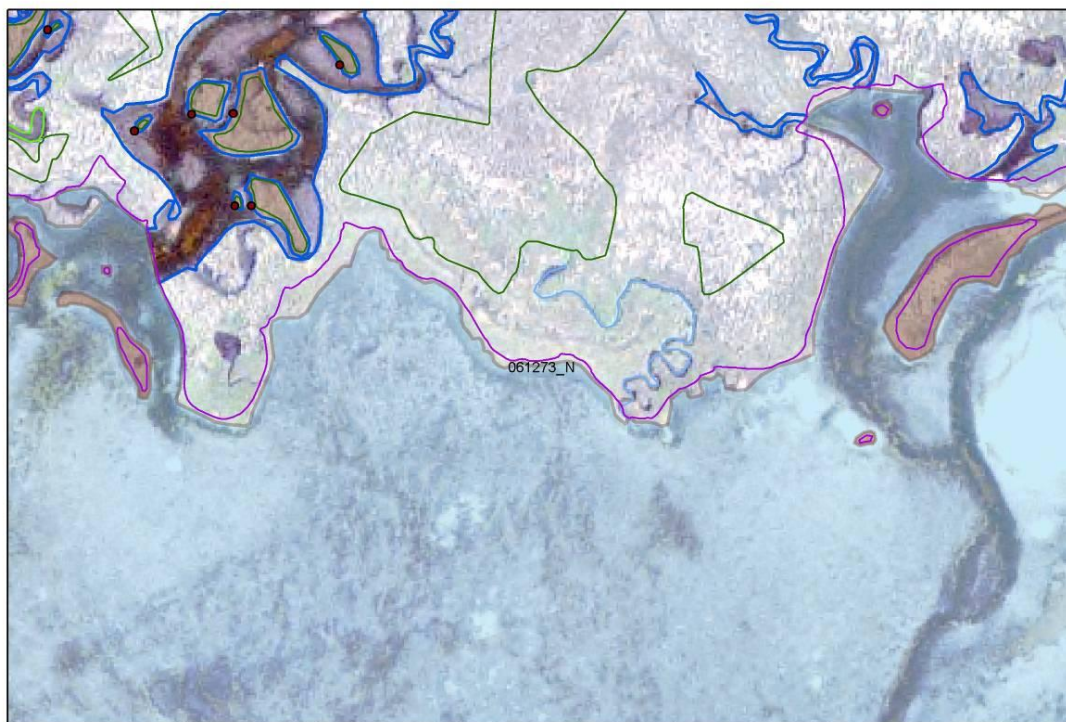
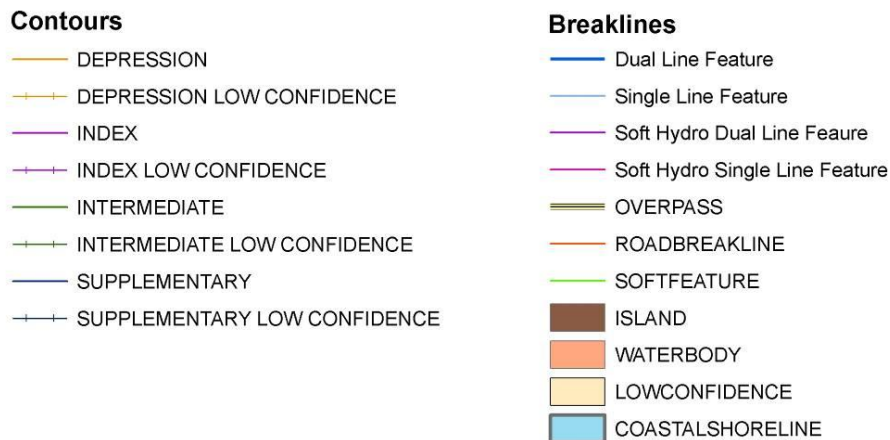
Coastal shorelines are correctly captured as two-dimensional polygon features, extracted from the LiDAR data and not from digital orthophotos, except for manmade features with varying heights such as seawalls which are captured as three-dimensional breaklines. Coastal breaklines merge seamlessly with linear hydrographic features. Shorelines continue beneath docks and piers. There is no “stair-stepping” of coastal shorelines. Figure 1 shows example coastal breaklines and contours.

Figure 1. Example coastal breaklines and contours from tile #61273

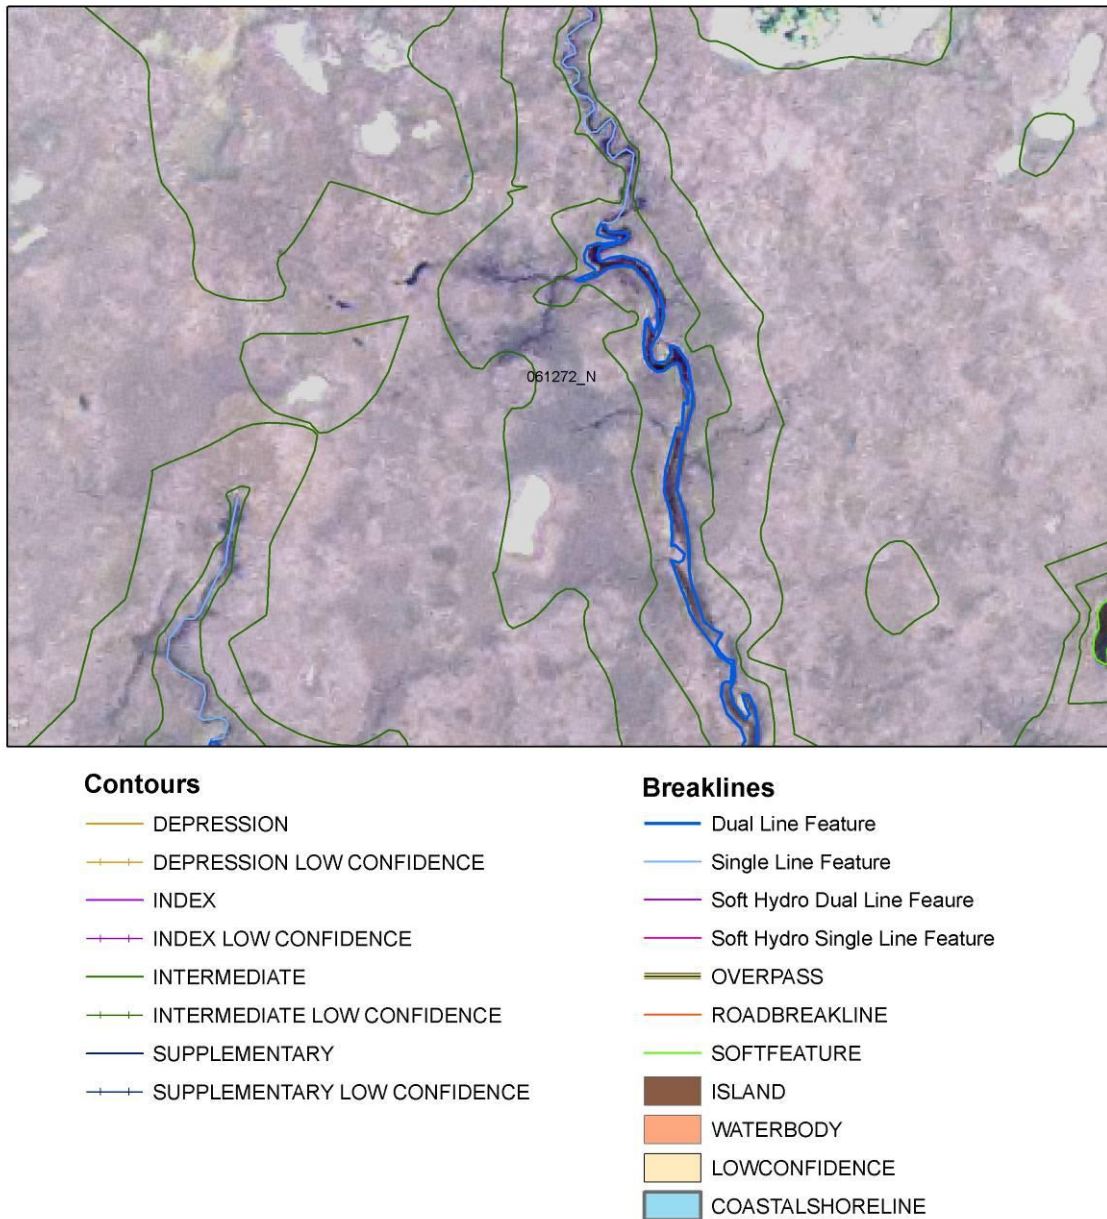
Linear hydrographic features are correctly captured as three-dimensional breaklines – single line features if the average width is 8 feet or less and dual line features if the average width is greater than 8 feet. Each vertex maintains vertical integrity. Figure 2 shows example breaklines and contours of linear hydrographic features.

Figure 2. Example linear hydrographic feature breaklines and contours from tile # 61272

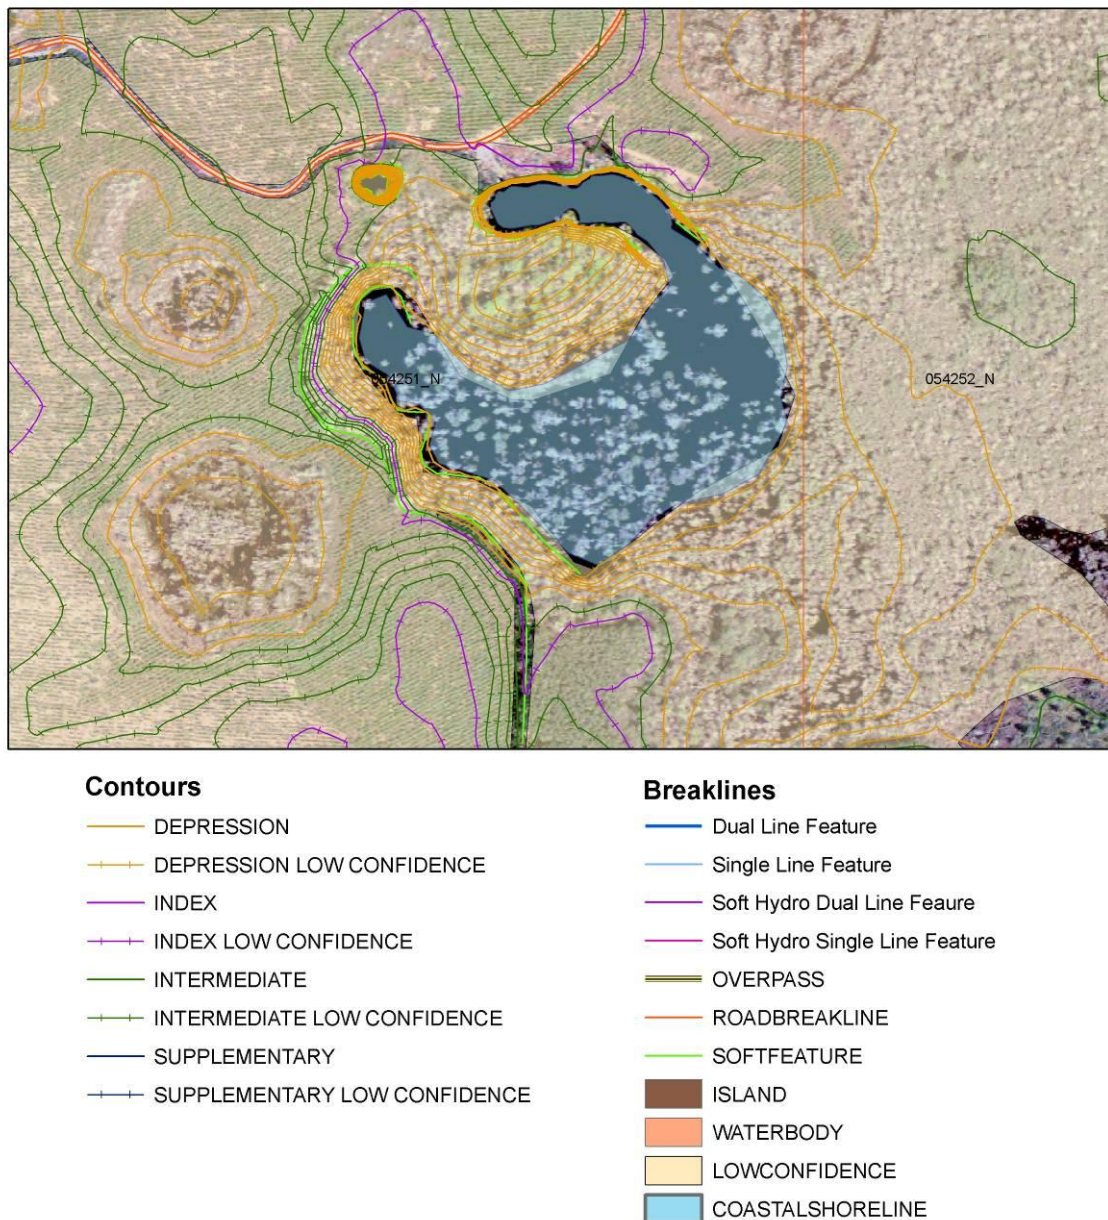
Closed water body features with an area of one-half acre or greater are correctly captured as two-dimensional closed polygons with a constant elevation that reflects the best estimate of the water elevation at the time of data capture. “Donuts” exist where there are islands within a closed water body feature. Figure 3 shows example breaklines and contours of closed water body features.

Figure 3. Example closed water body feature breaklines and contours from tile #54251

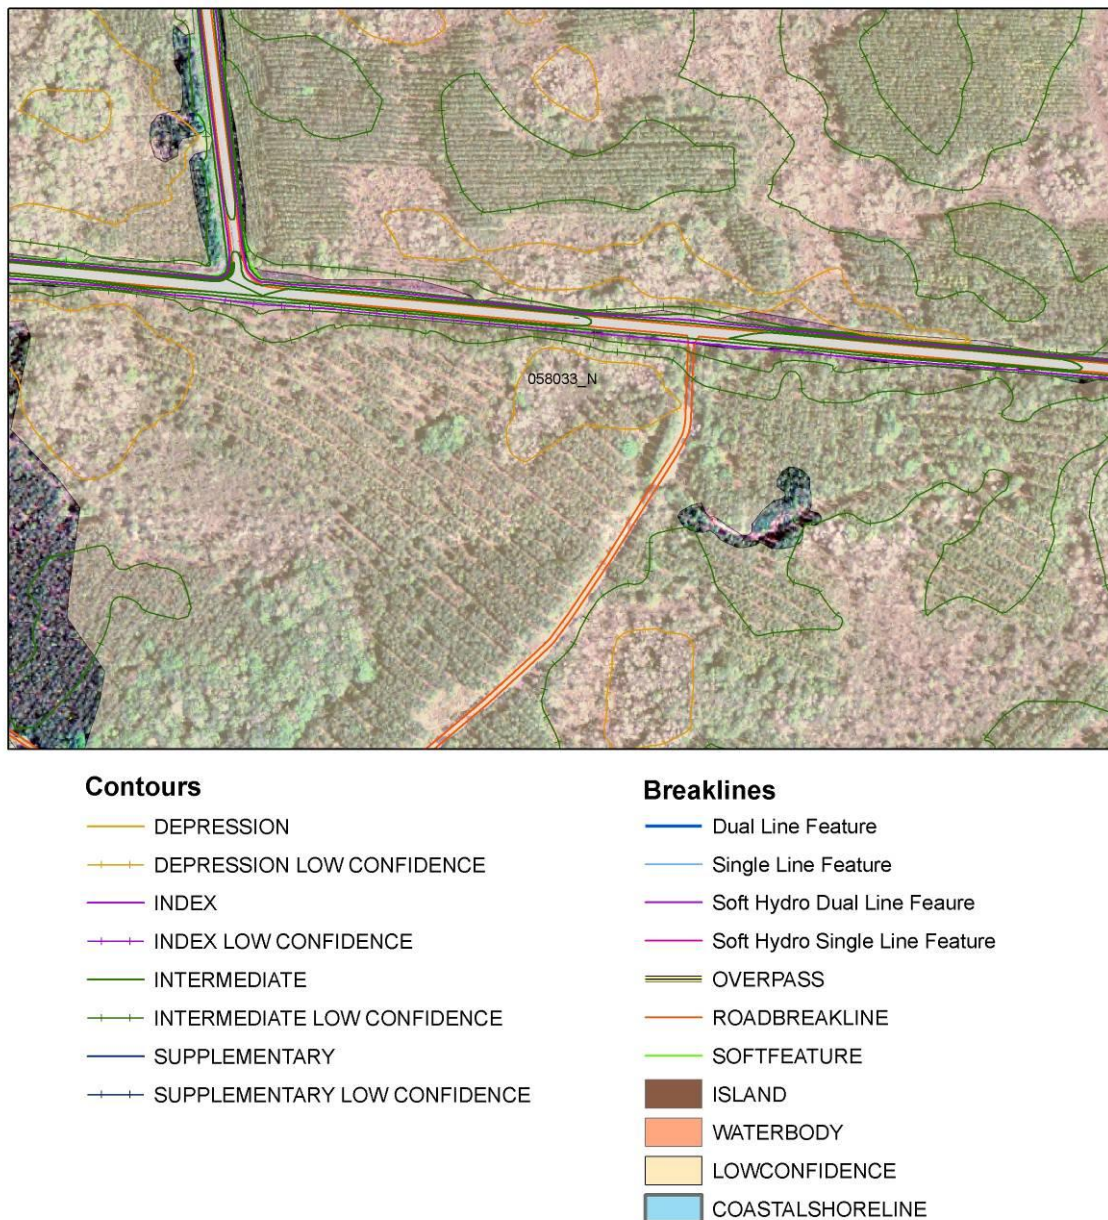
Figure 4. Example road feature breaklines and contours from tiles #58033

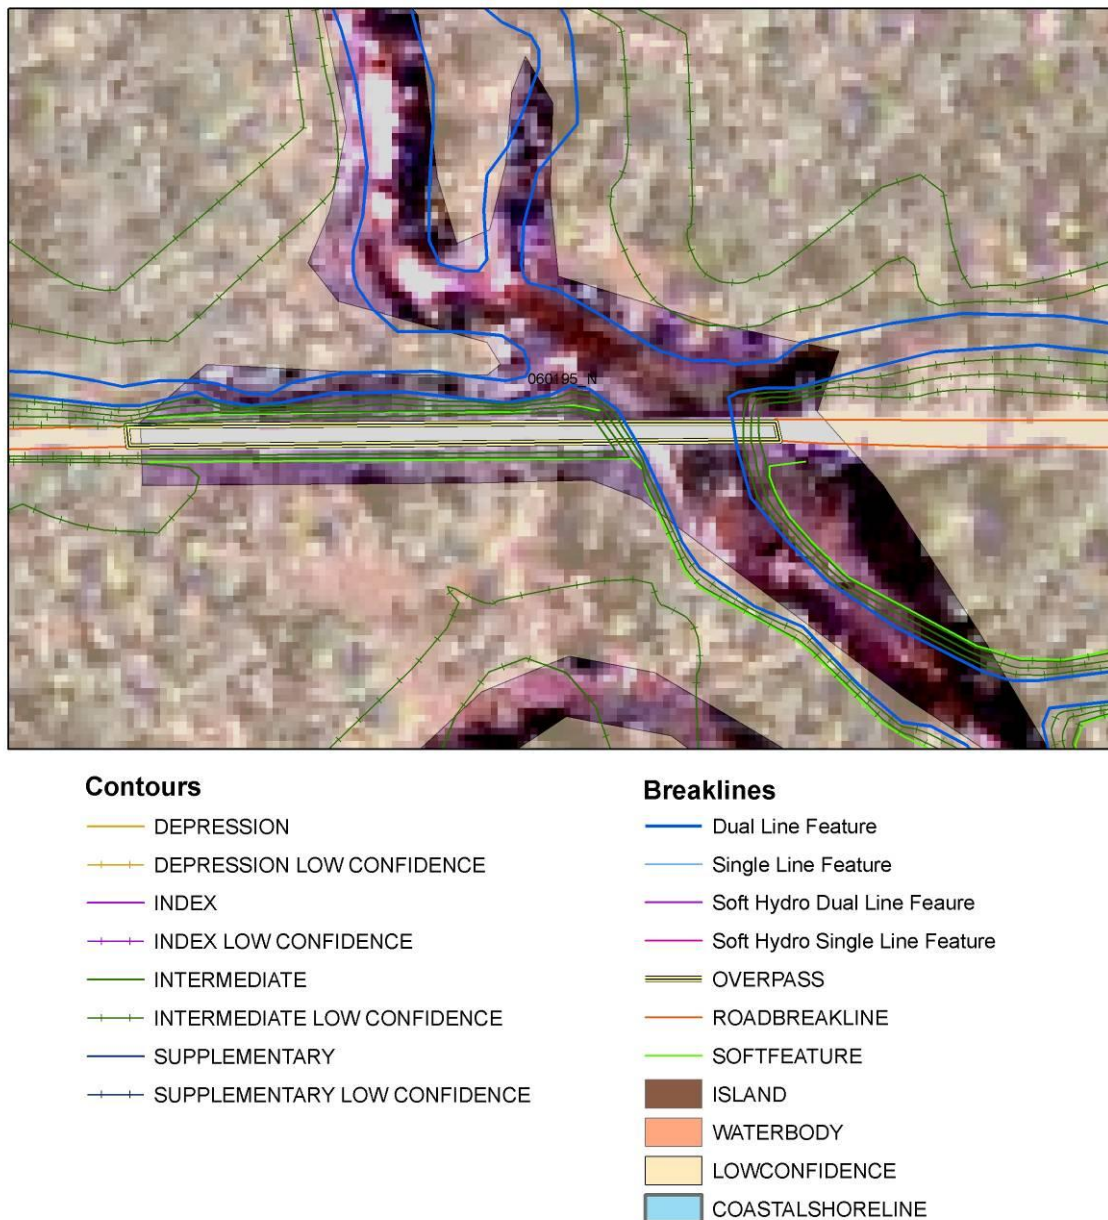
Figure 5. Example bridge and overpass feature breaklines and contours from tile # 60195

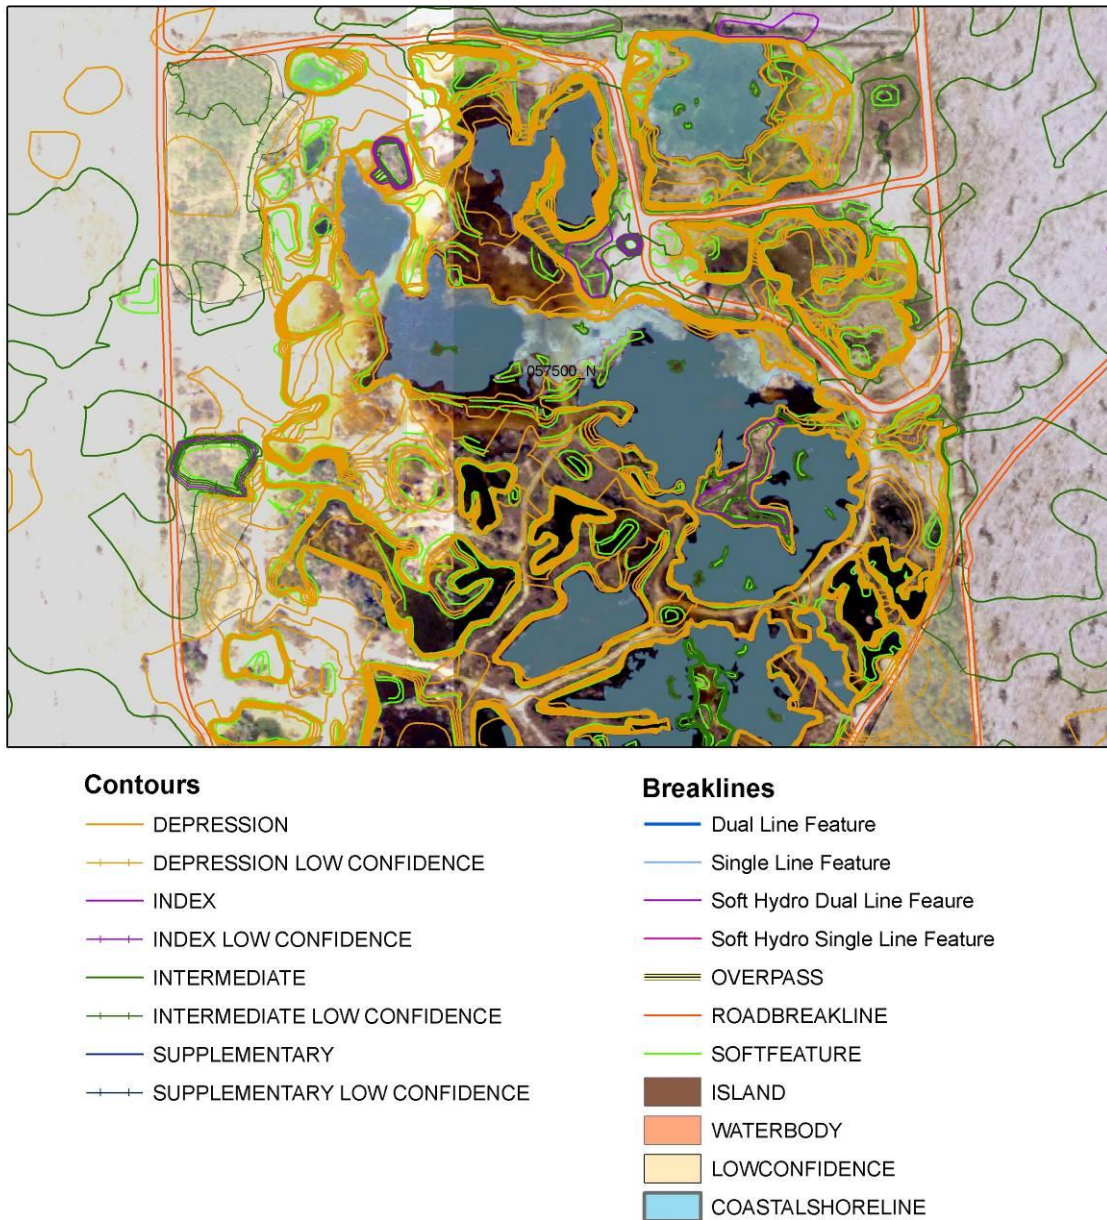
Figure 6. Example soft feature breaklines and contours from tile #57500

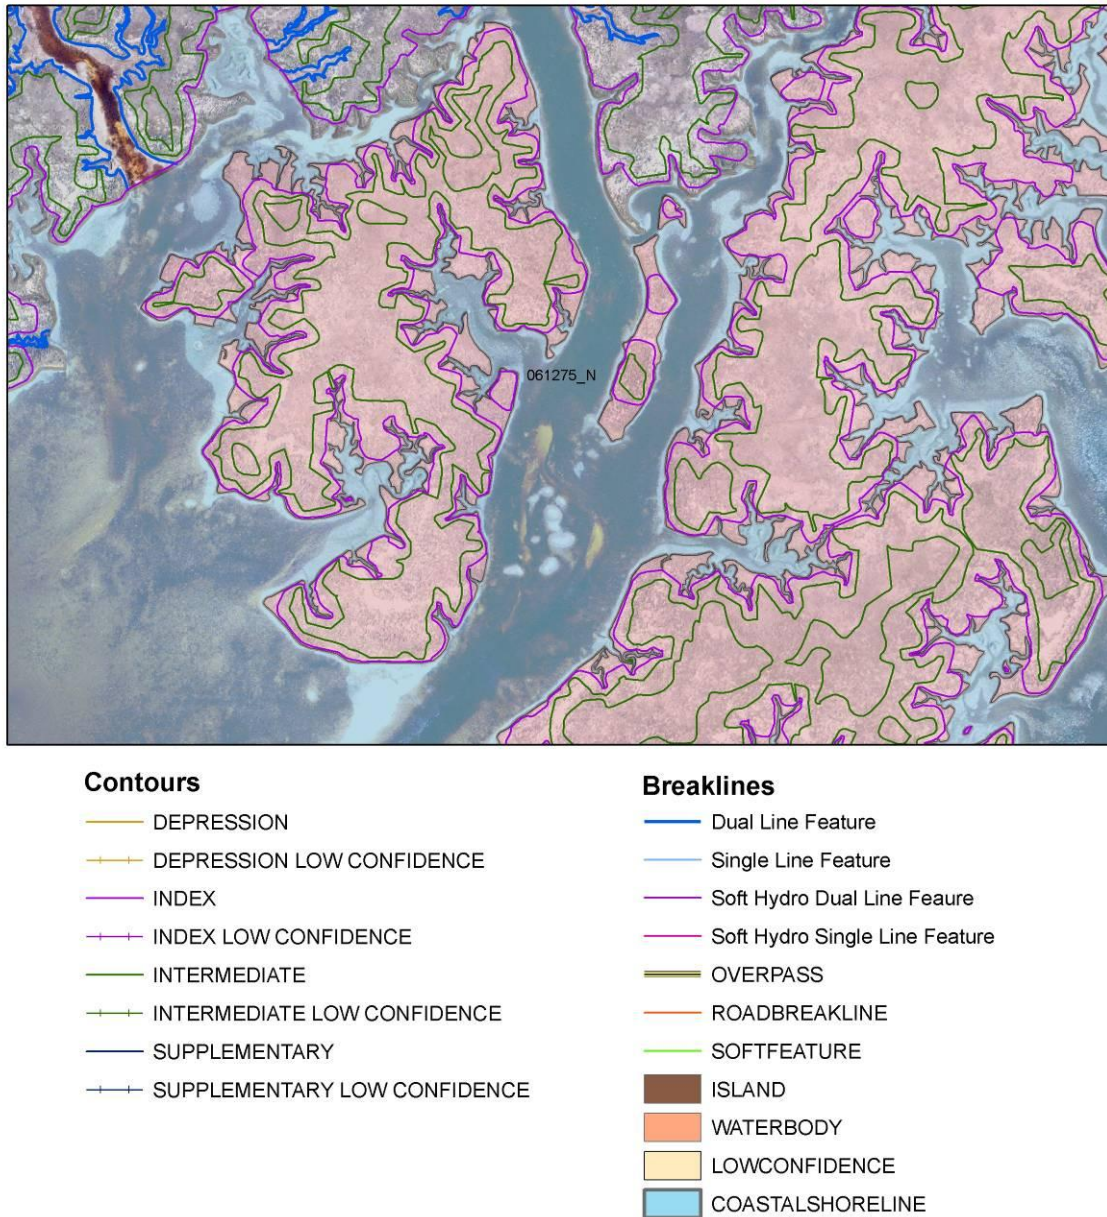
Figure 7. Example island feature breaklines and contours from tiles # 61275

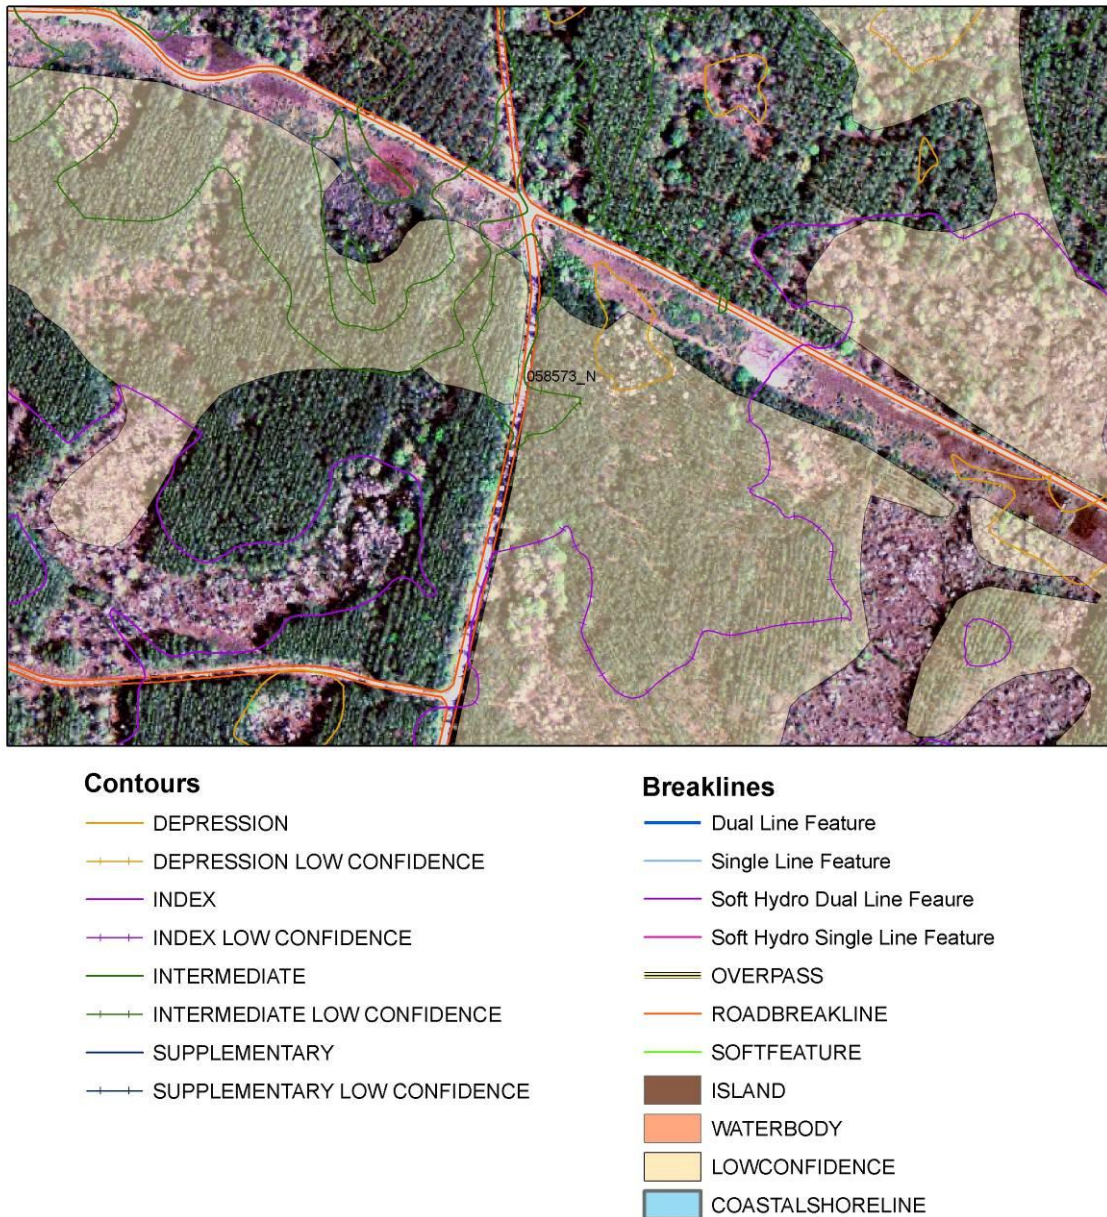
Figure 8. Example low confidence area feature breaklines and contours from tile # 58573
